RESEARCH MEMORANDUM

LATERAL AND DIRECTIONAL STABILITY AND CONTROL
CHARACTERISTICS OF A C-54D AIRPLANE

Donald B. Talmage and John P. Reeder

March 24, 1949

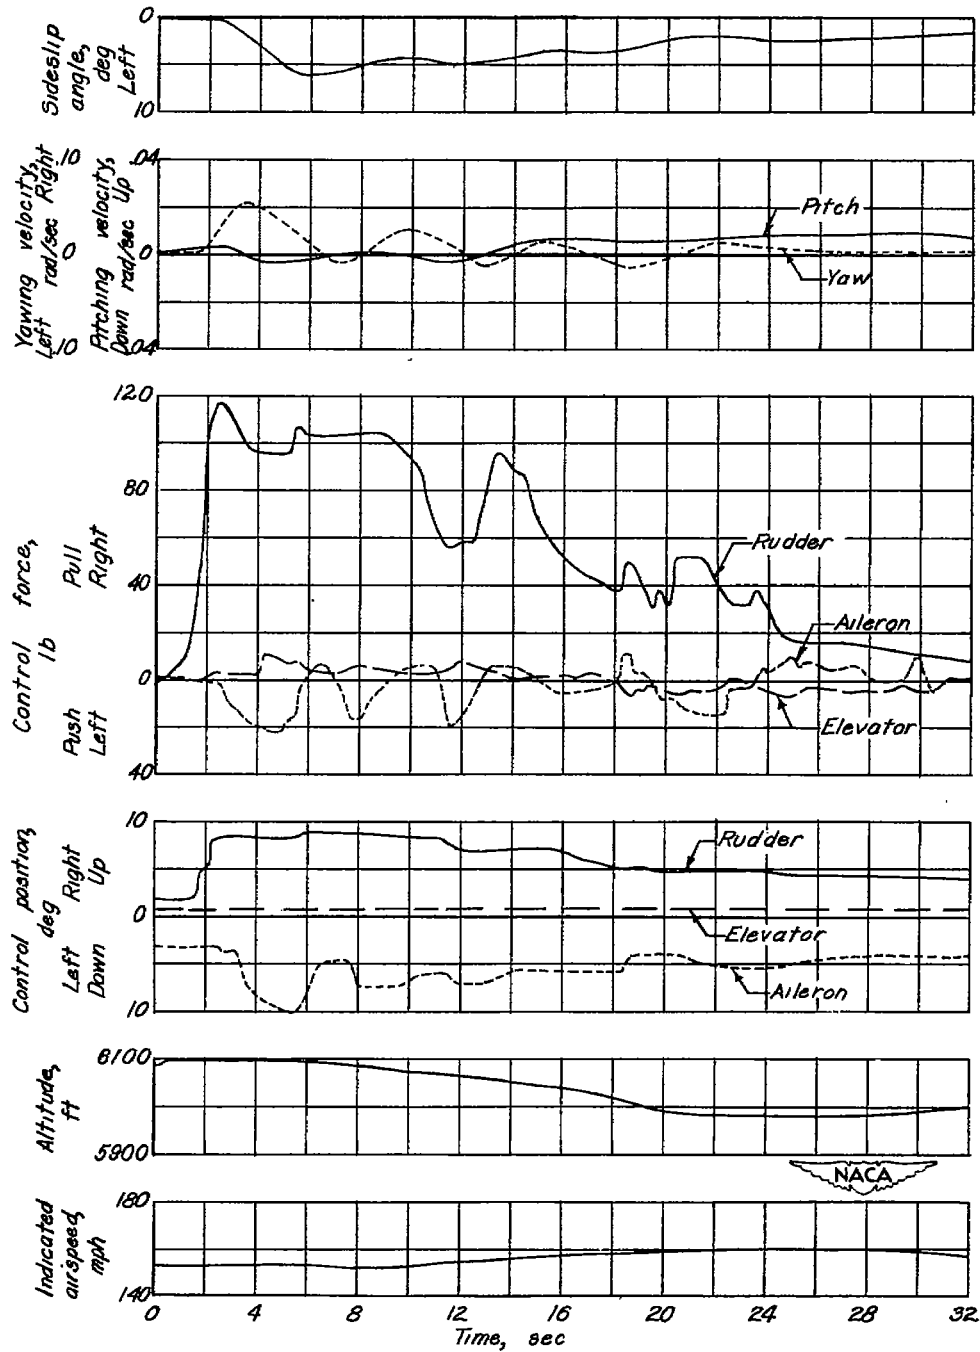
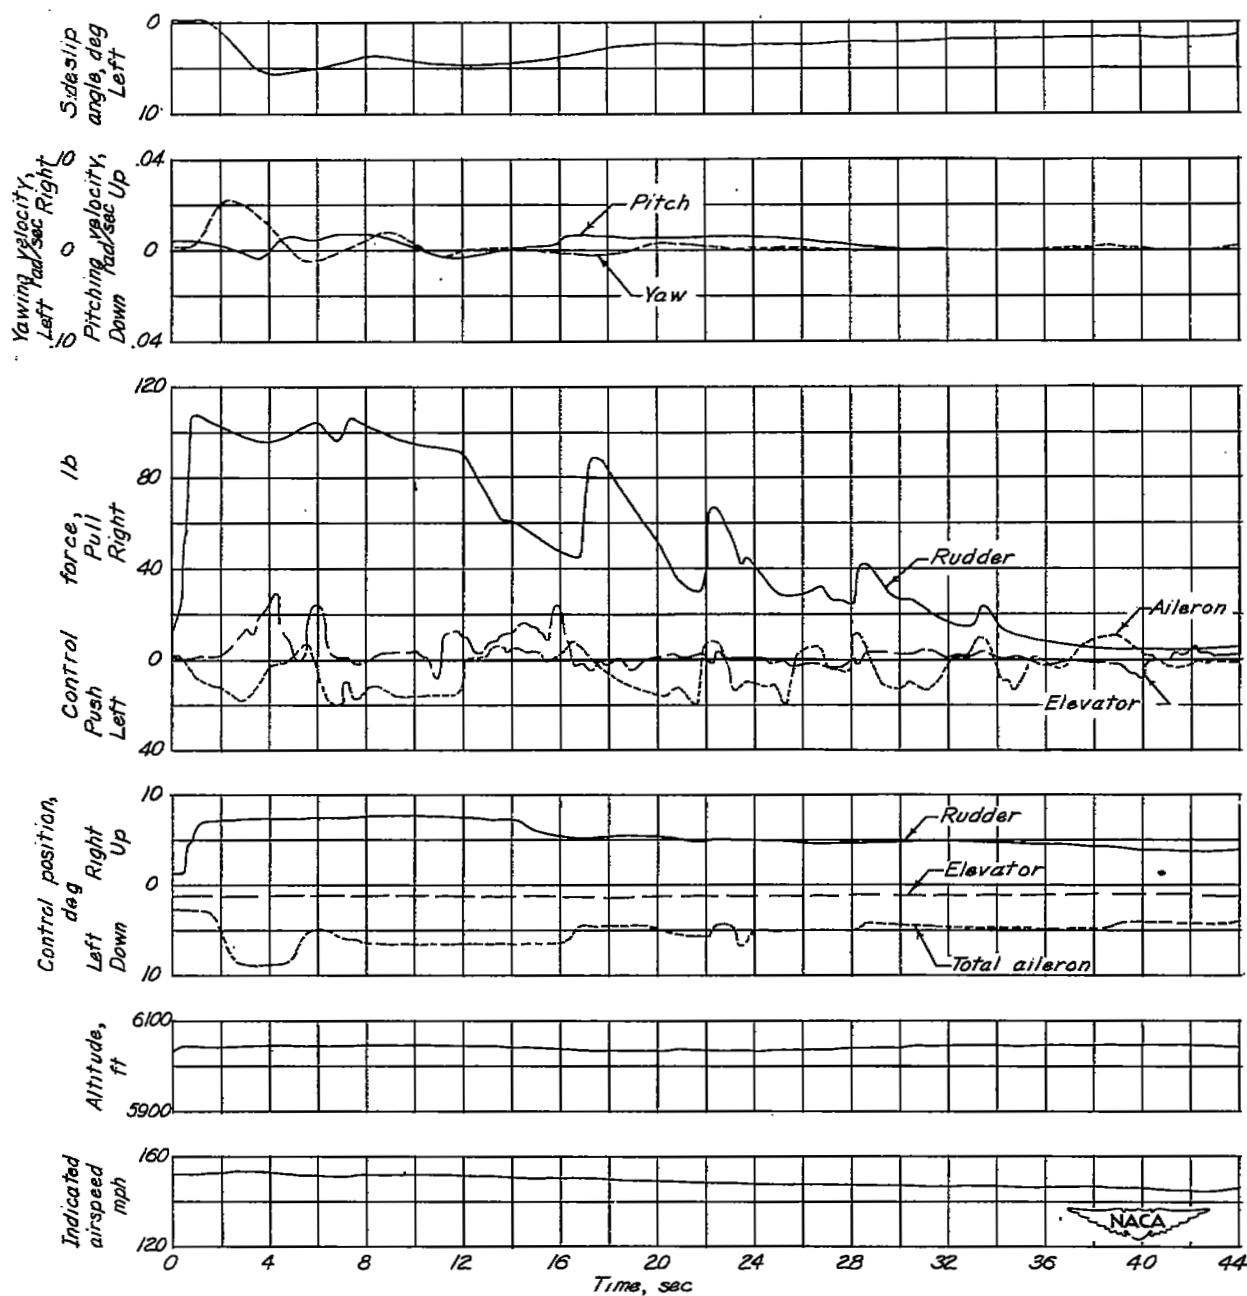
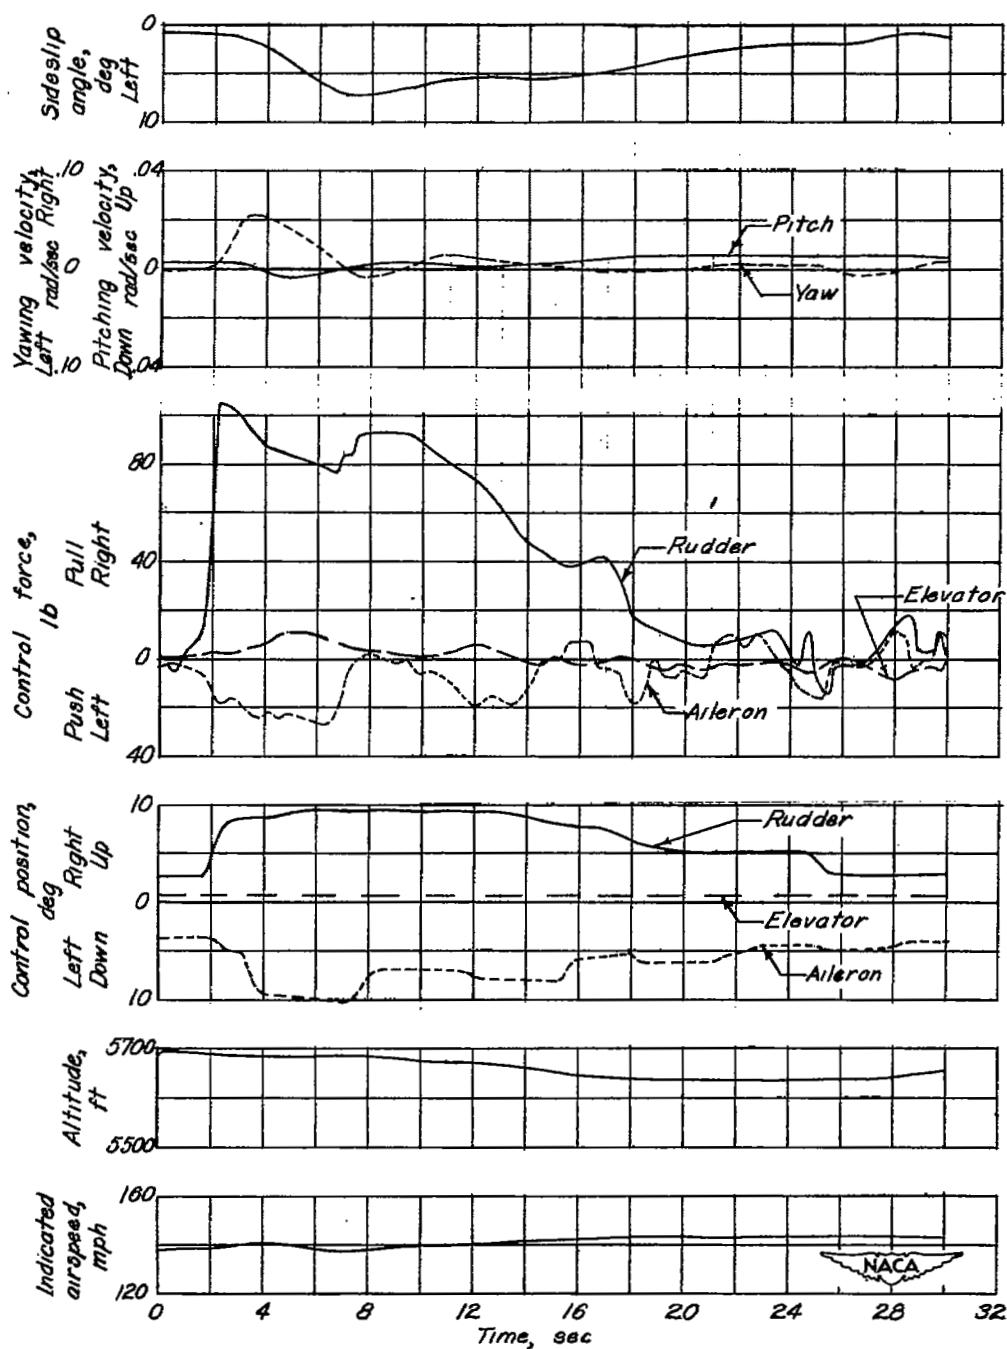
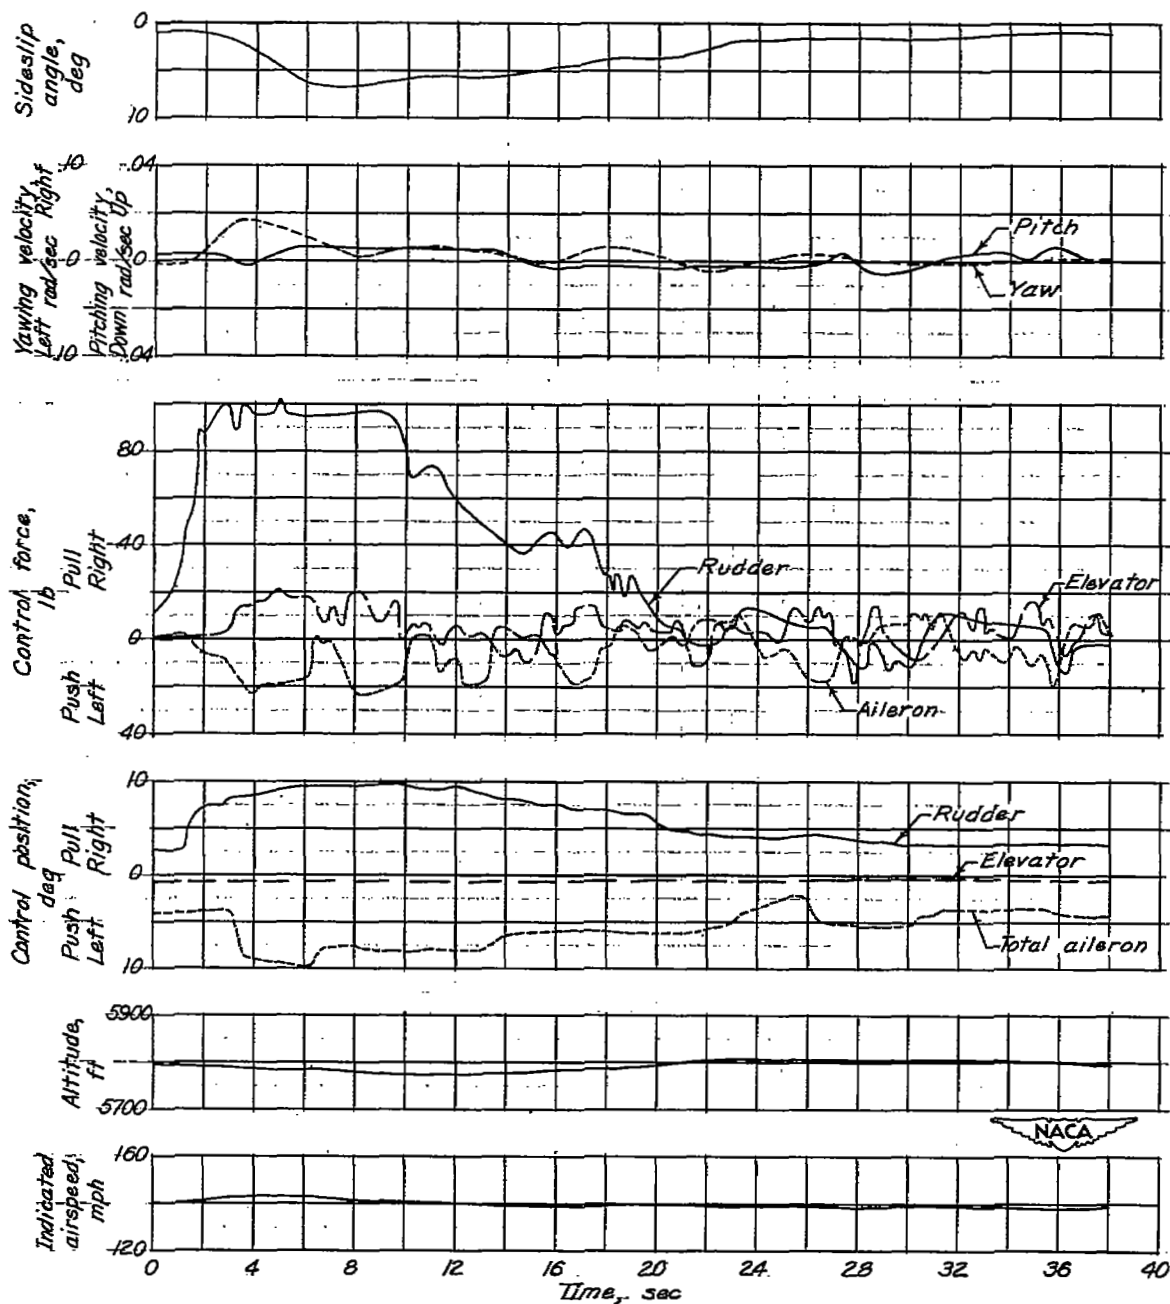
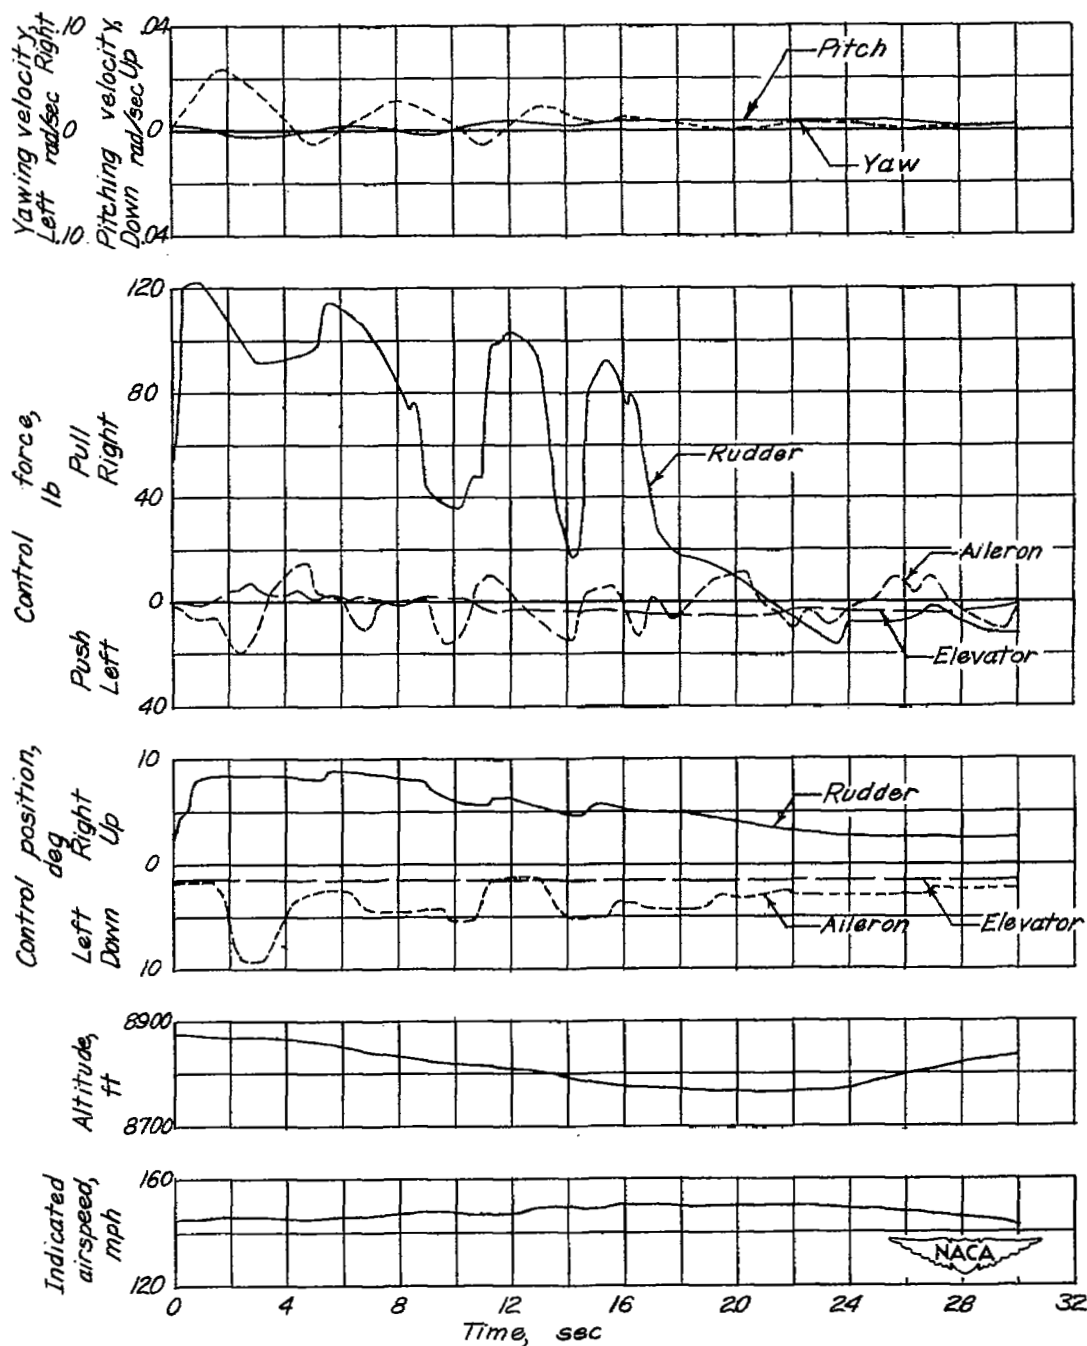
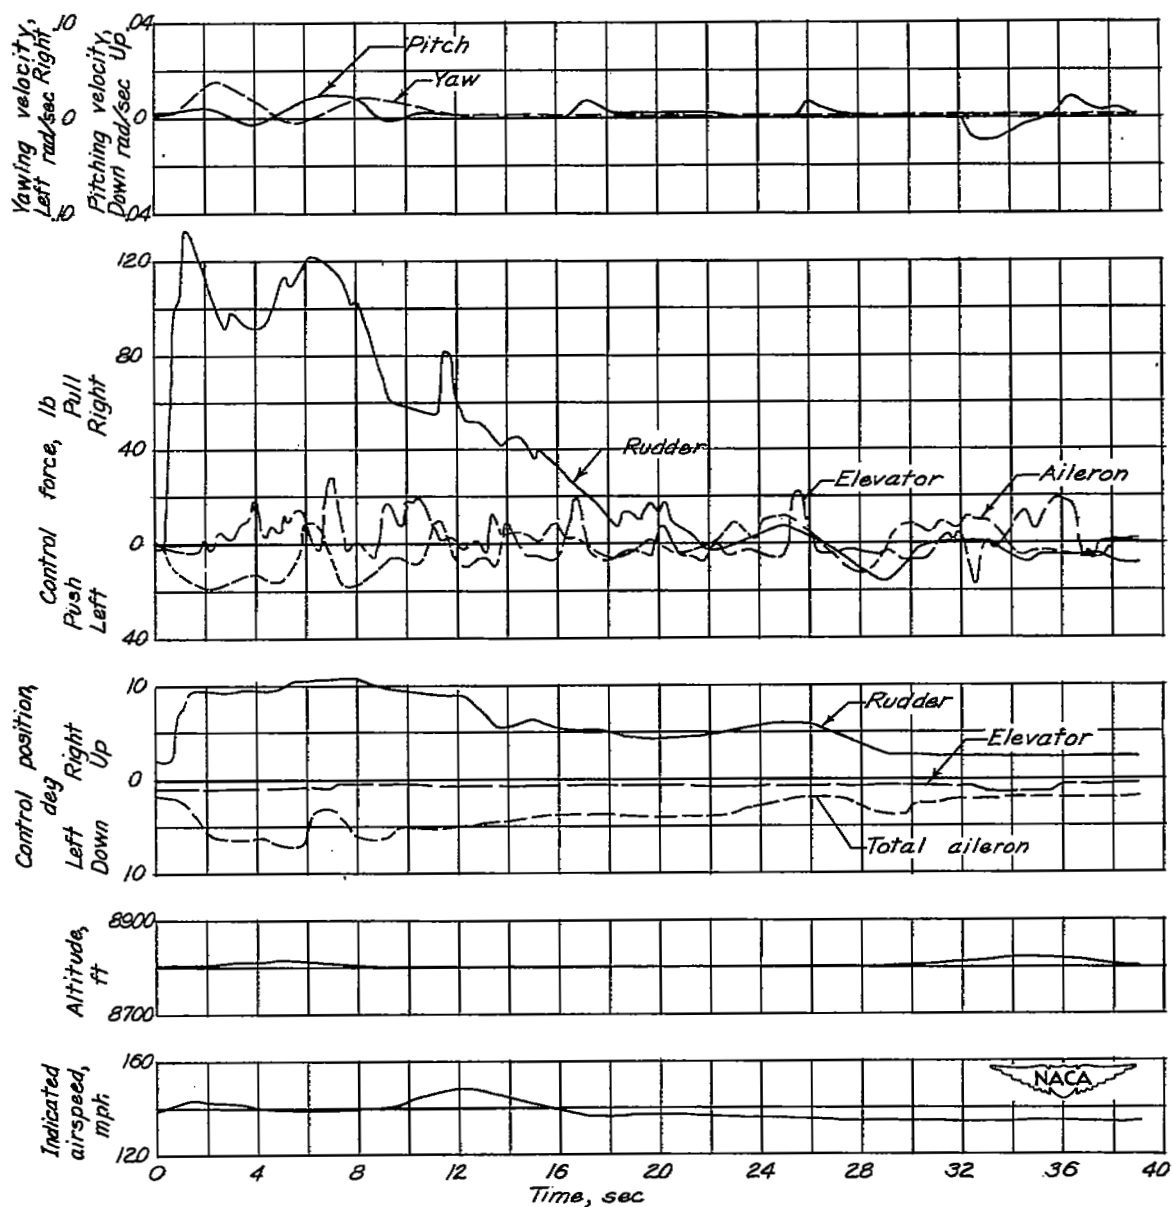
Figure 14.— Time histories of 10° heading changes holding the wings level. C-54D airplane.

Special tests were made to determine the ability of the pilot to hold altitude while making wing-level skid turns. This maneuver was suggested as the manner of changing heading on blind approaches when the altitude is so low that the pilot would need to be cautious not to strike the ground with a wing tip. In such a maneuver, any unnoticed pitching could cause an undesirable loss in altitude. Figure 14 presents time histories of several skid turns in different conditions with the altitude controlled and with the altitude uncontrolled. With the altitude uncontrolled, the airplane lost altitude only in right turns. In left turns altitude was gained in a few cases as shown in figure 14(c) but in no instance was any loss in altitude found. This pitching tendency was not noticeable for changes of heading of 5° and less. Consequently, figure 14 presents only changes of heading of 10° . Since the main consideration of the tests was loss in altitude, records were taken of left-skid turns in only one condition. The tendency to pitch down in right turns and up in left turns can be traced to the gyroscopic action of the propellers.

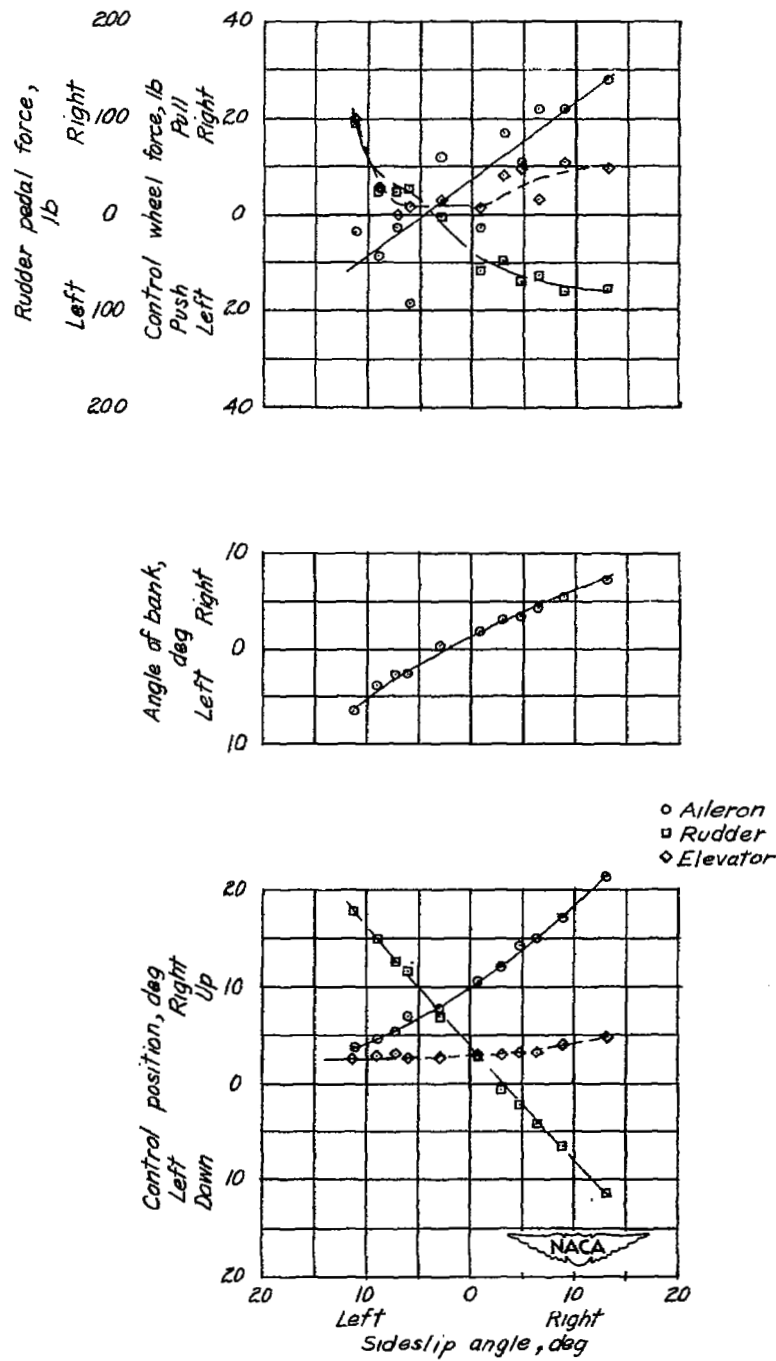
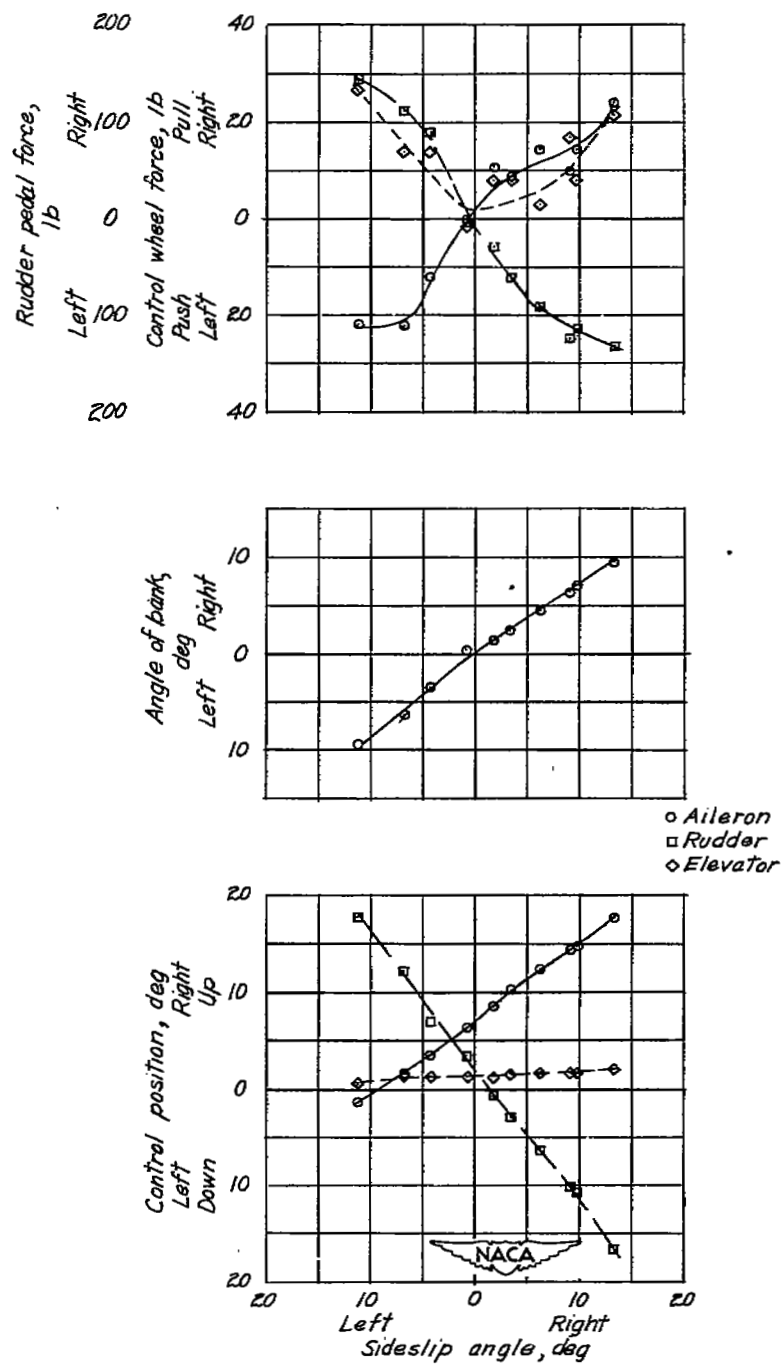
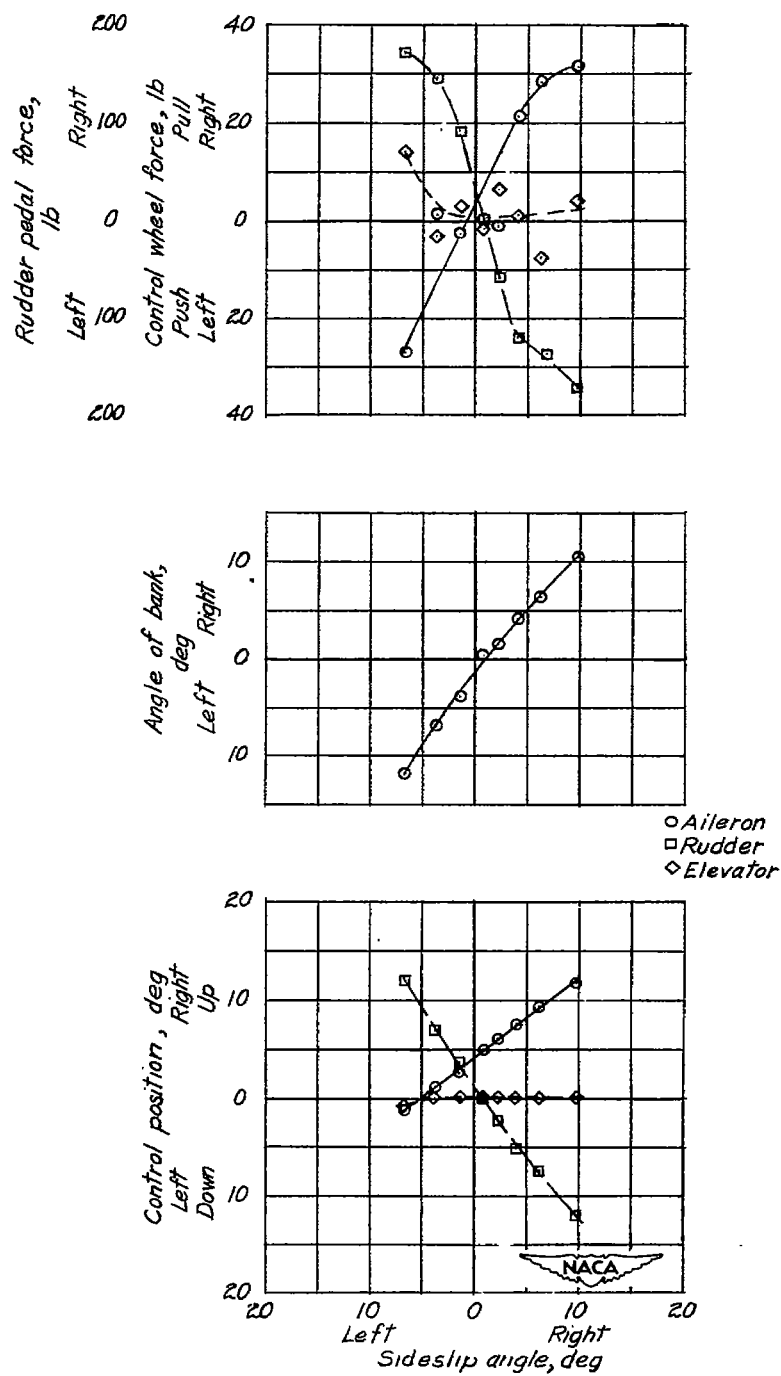
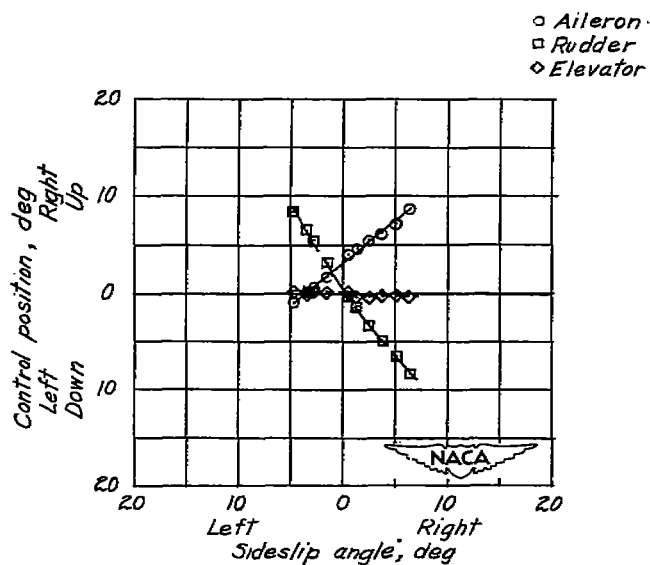
Figure 15.— Sideslip characteristics with asymmetric load.
 C-54D airplane; clean condition; normal rated power; right wing-tip gas tank empty.

Special tests were made at the request of the Airplane Handling Qualities Subcommittee of the Air Transport Association to determine the feasibility of take-offs and landings with one outboard tank empty. Steady sideslips, the data for which are presented in figure 15, were made at several speeds in the clean conditions with the right wing-tip tank empty. The only disadvantage found was the restricted aileron travel in the right direction due to the amount of aileron necessary to balance the asymmetric load. The aileron travel, however, was not limited to such an extent that balancing at large angles of sideslip was impossible. Approximately 40 percent of full aileron deflection was required for lateral trim at 120 miles per hour. The restricted aileron travel would result in limited $pb/2V$ in the direction of the light wing, but since the remaining travel is still within the limits normally called for in blind approaches (reference 1), ferrying flights could be made with one outboard tank empty without undue risk.

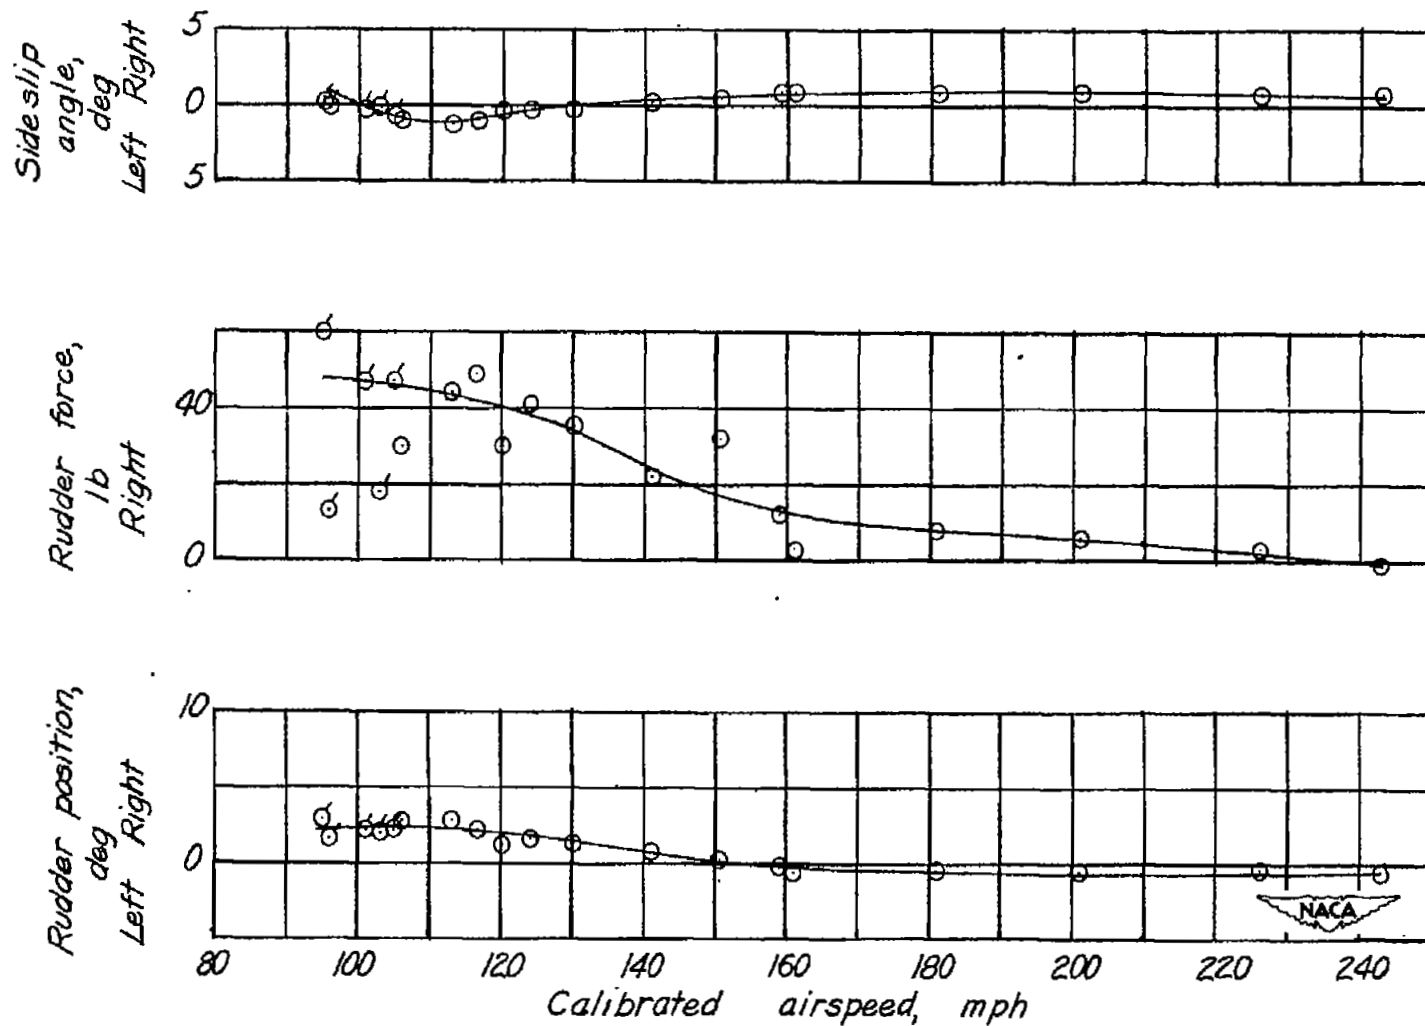
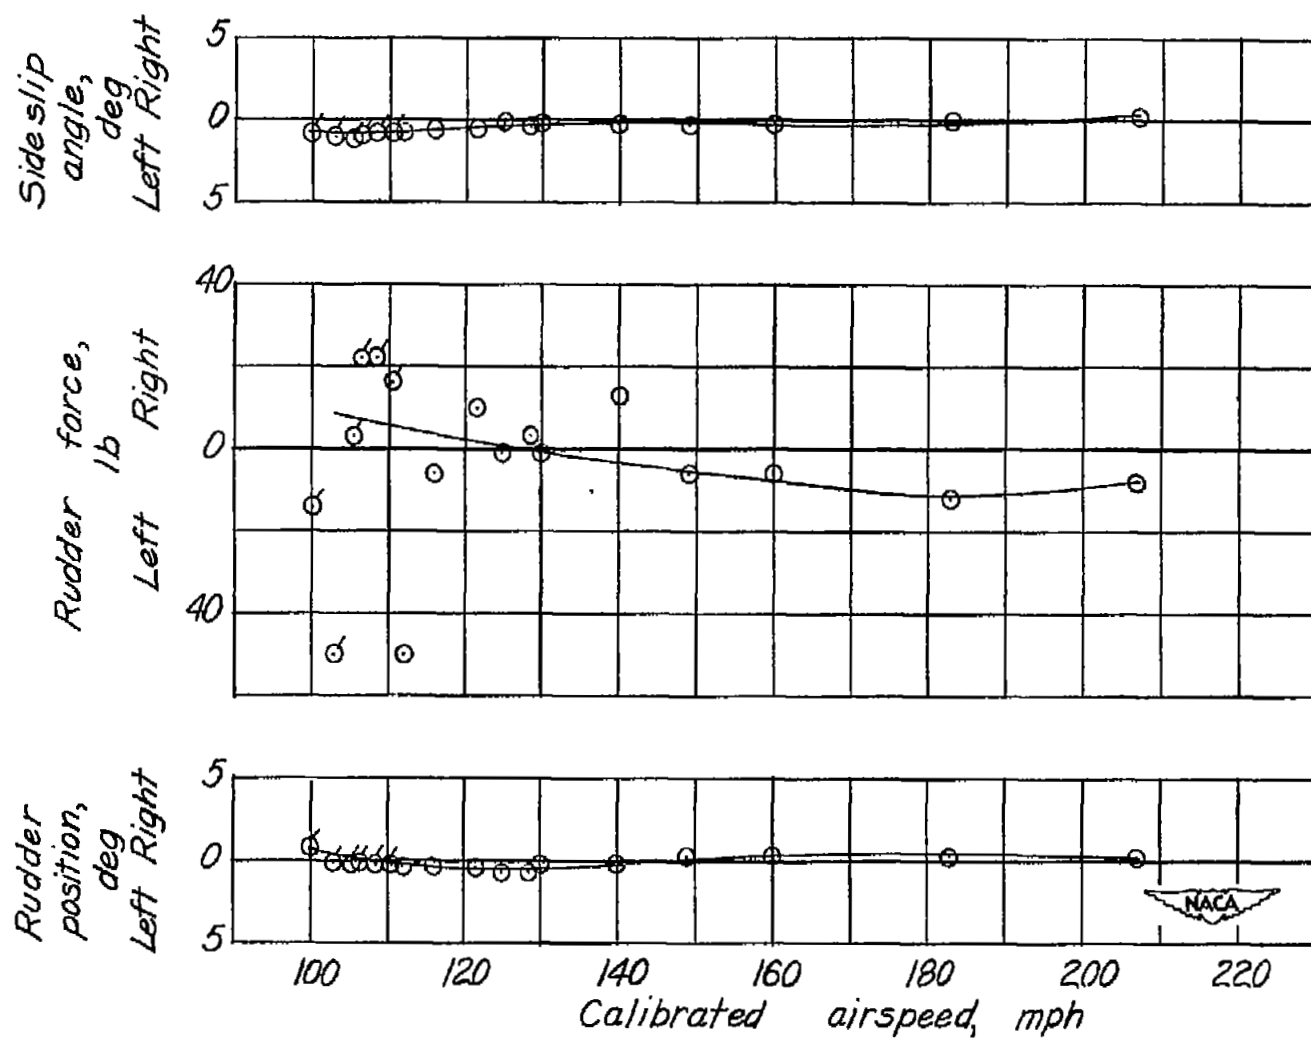
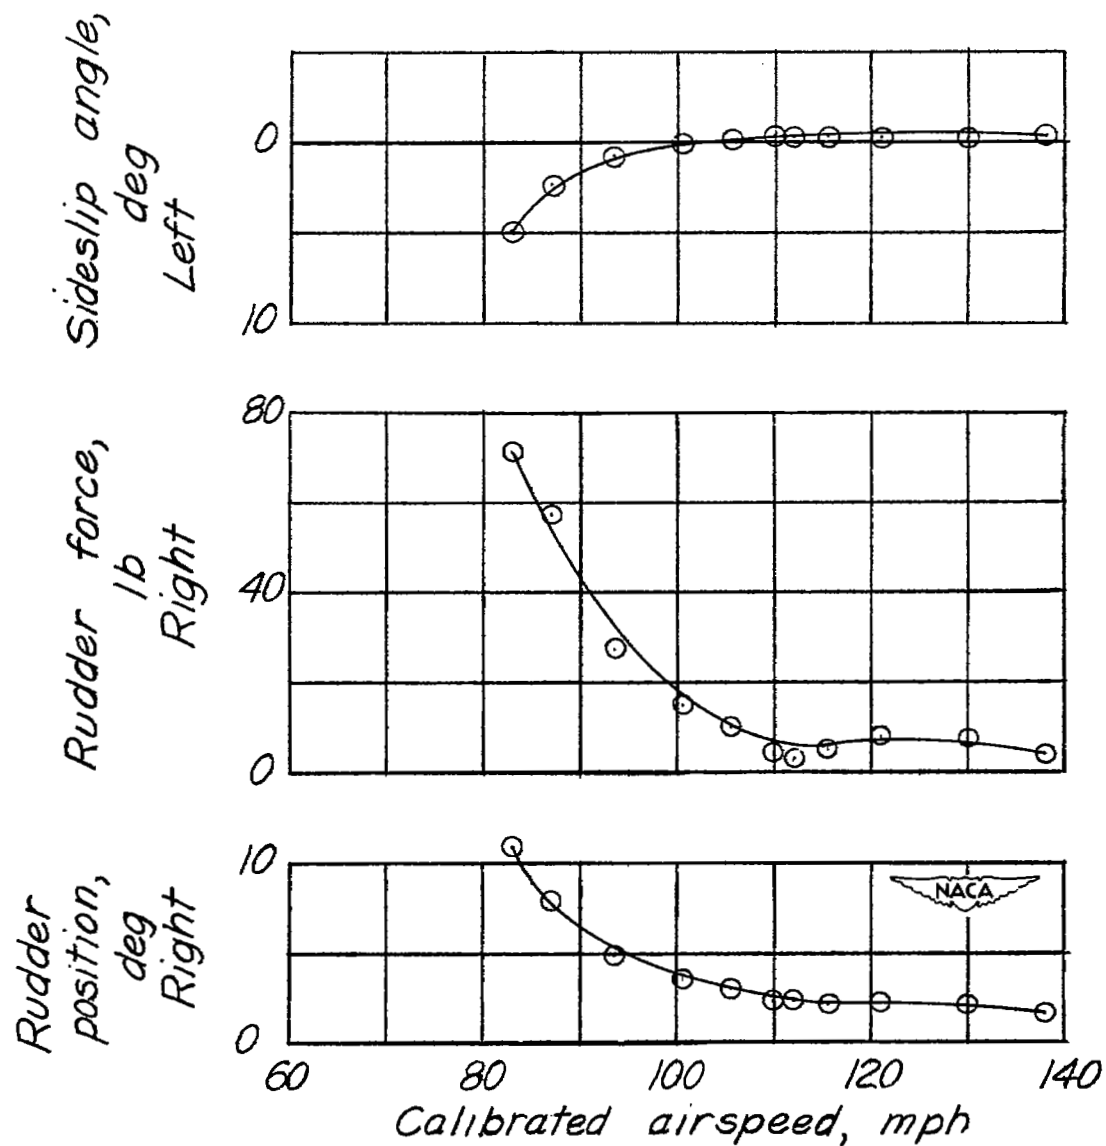
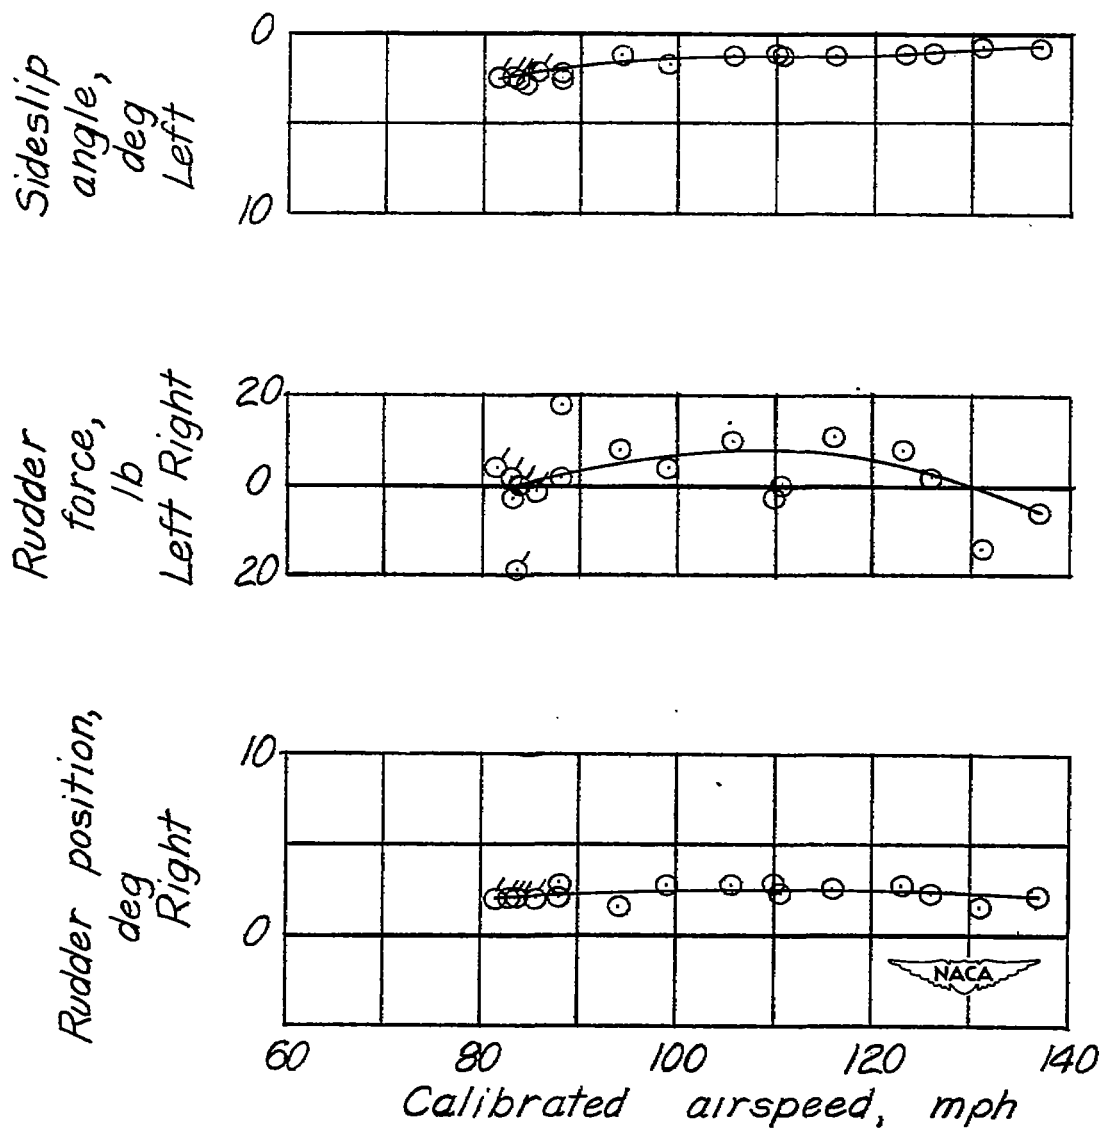
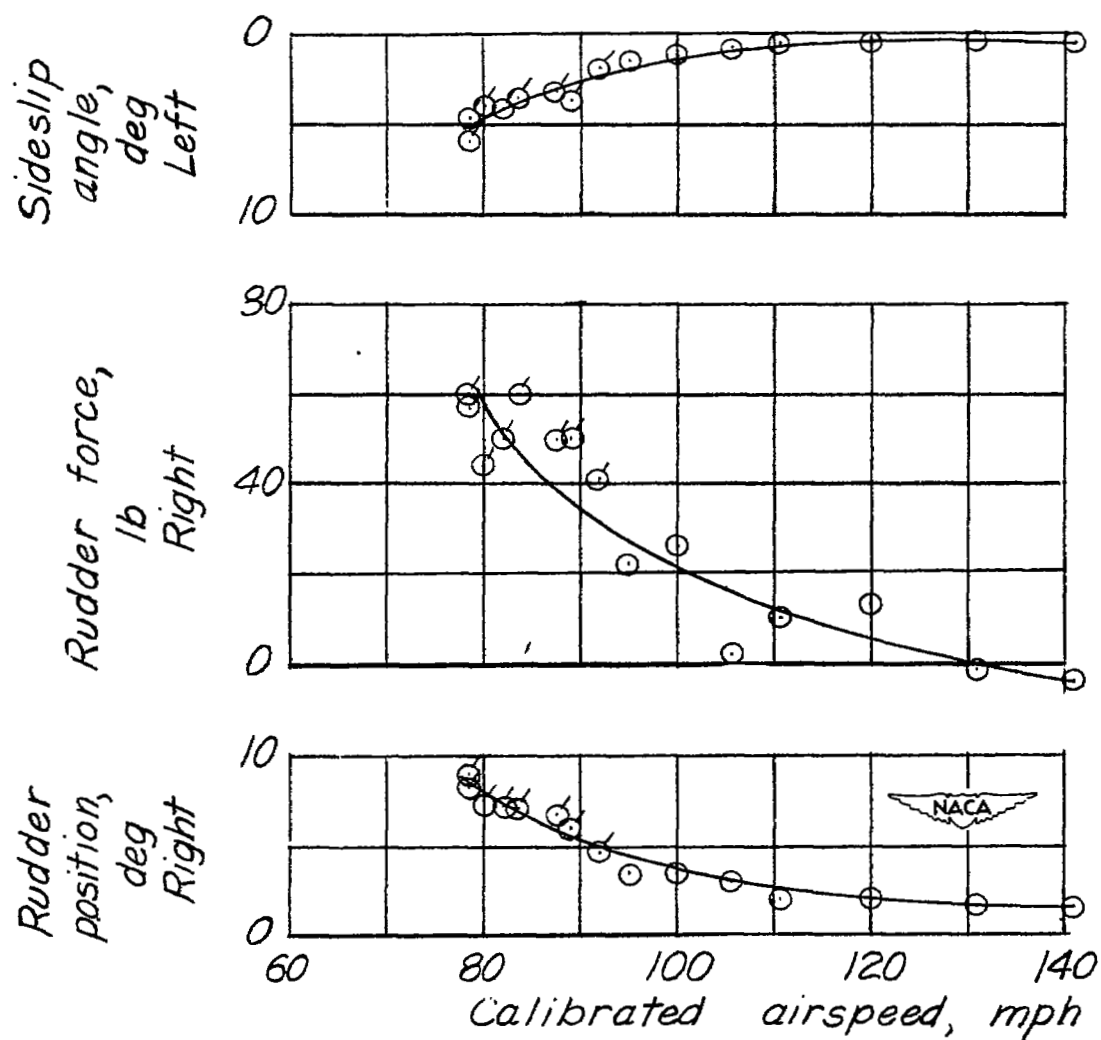
Figure 16.— Directional trim characteristics. C-54D airplane.

The directional-trim characteristics were measured in steady straight flight. These characteristics are presented in figure 16. The requirement that the rudder control shall give sufficient directional control to trim the airplane in steady level flight at all speeds in all conditions was satisfied.

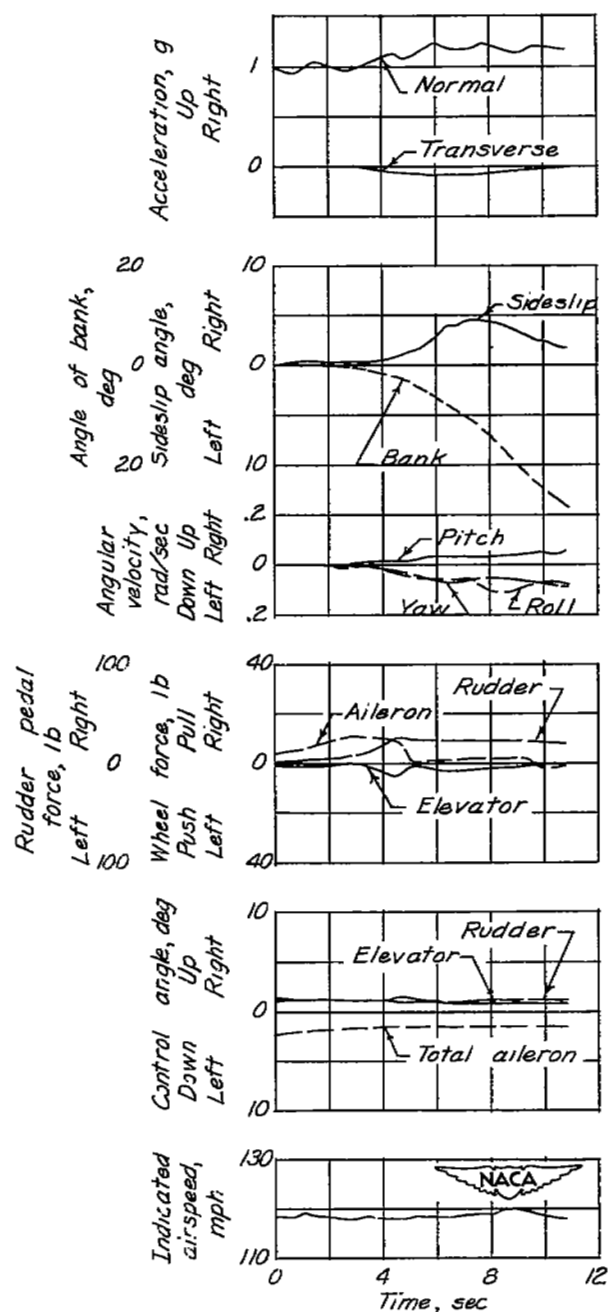
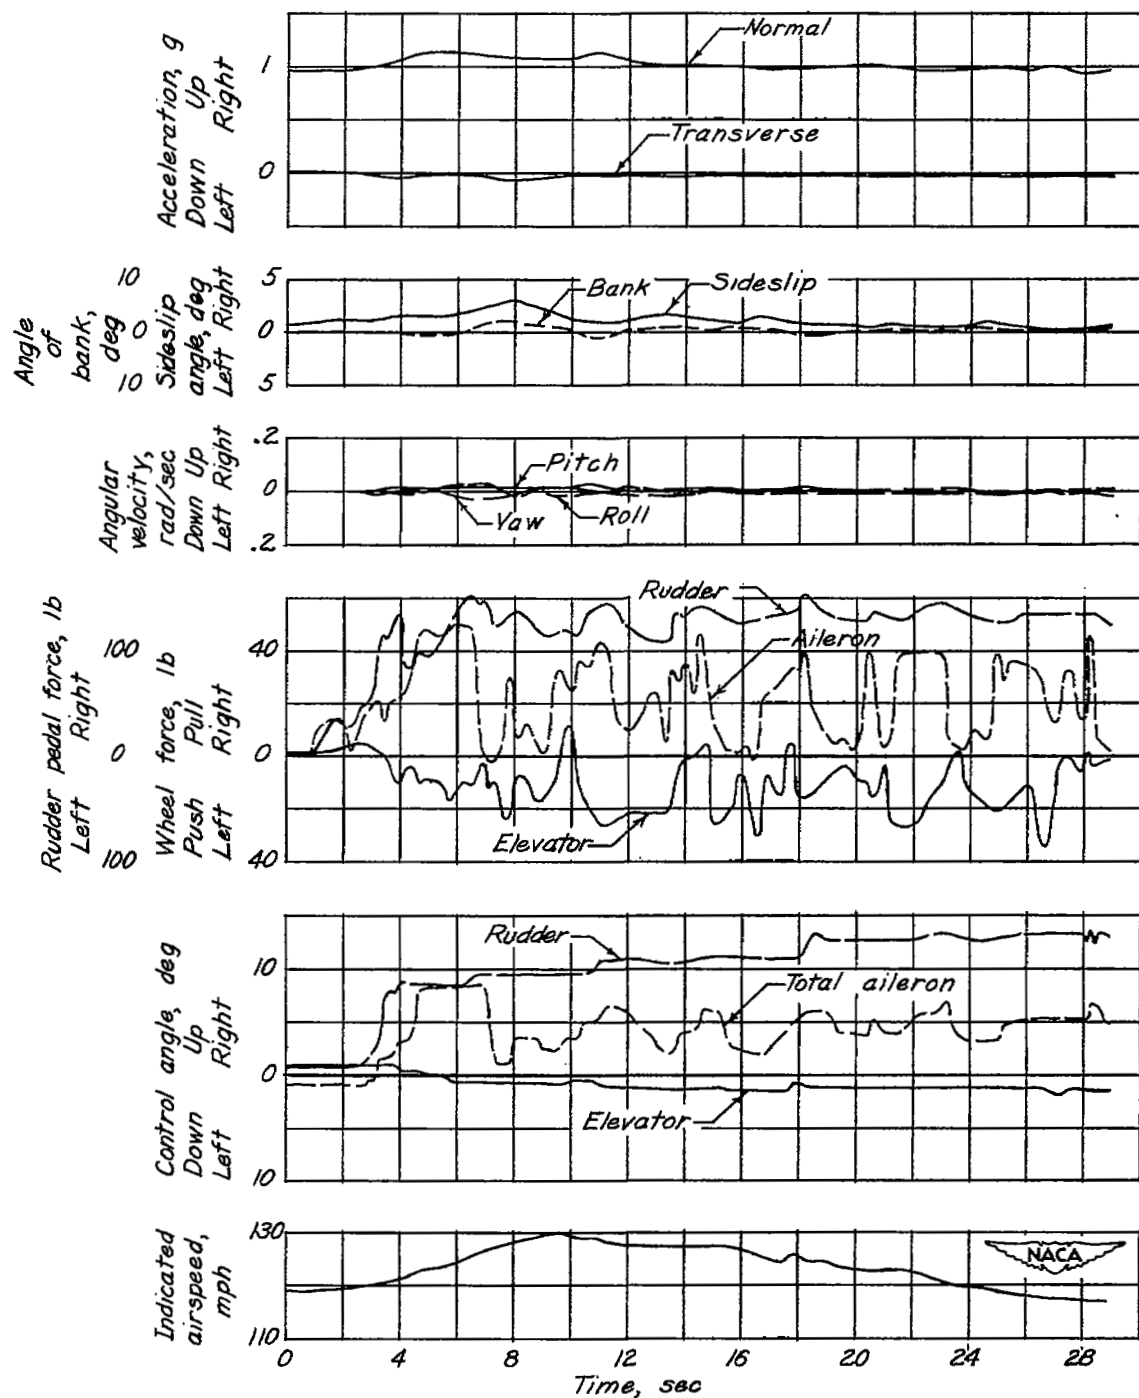
Figure 17.— Time histories of airplane motions during a wave-off in which No. 1 engine fails as power is applied. C-54D airplane; flaps full down; gear down; power initially off, but increased to 45 in. Hg during first three seconds.

Uncontrolled attitude changes due to asymmetric power.— At the request of the Airplane Handling Qualities Subcommittee of the Air Transport Association special tests were run to determine the time it would take to reach a dangerous attitude if no corrective control were applied upon the complete loss of power of the most critical engine. Records were taken of the airplane motions and the control angles and forces during the simulated loss of number 1 engine (left outboard). Time histories of these maneuvers in both the take-off and wave-off condition with and without corrective control are presented in figures 17 and 18. The angle of bank presented was obtained from an integration of the record of the rolling velocity. The sideslip angle remained small throughout the maneuver and consequently the rapid deviation from the straight and level flight path associated with large angles of sideslip did not appear. The time to reach a dangerous

attitude was about 7 seconds in the take-off condition and longer in the wave-off condition. It is felt that 7 seconds is sufficient time for the pilot to cope with the emergency and be able to recover with ease.
